CAN Microcontrollers

T89C51CC01
T89C51CC01UA
T89C51CC01CA

Errata Sheet

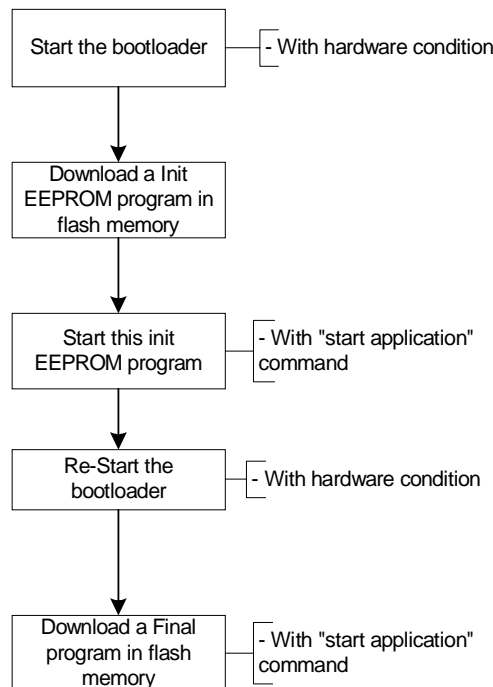
16. EEPROM – Lock-up during ISP write

Program lock-up can be experienced when using Atmel FLIP software or a custom In system Pogramming tools to write in the internal EEPROM. This problem occurs with clock frequency > 12MHz in X2 mode or 24MHz in X1 mode. Neither the code Flash nor the EEPROM are corrupted by the lock-up. Although the EEPROM cannot be written by the bootloader.

This problem is bootloader related and doesn't affect the capability for the user to read and write into the EEPROM. This problem is technology dependant. The likelihood of experiencing the problem is low at Clock frequency > 24 MHz in X1 mode and non-existent below. A reset can be applied to recover from the lock-up.

The following process can be done to work around the problem.

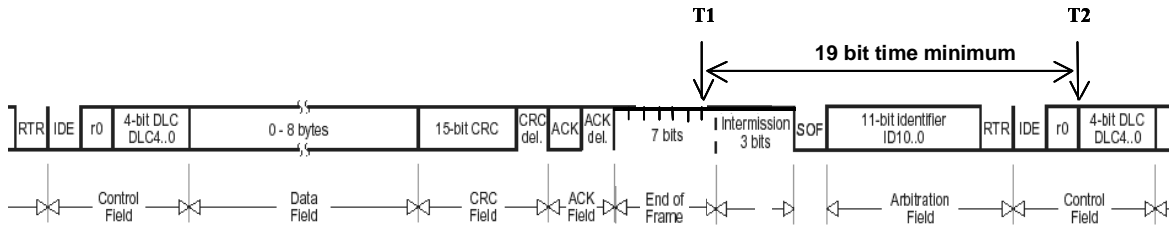
17. Transmission after a 3 bit Intermession

If a Transmit Message Object (MOB) is enabled while the CAN bus is busy with an on going message, the transmitter will wait for the 3-bit Intermession before starting its transmission. This is in full agreement with the CAN recommendation.

If the transmitter lost arbitration against another node, two conditions can occur :

1. At least one Receive MOB of the chip are programmed to accept the incoming message. In this case, the transmitter will wait for the next 3-bit Intermission to retry its transmission.
2. No Receive MOB of the chip are programmed to accept the incoming message. In this case the transmitter will wait for a 4-bit Intermission to retry its transmission. In this case, any other CAN nodes ready to transmit after a 3-bit Intermission will start transmit before the chip transmitter, even if their messages have lower priority IDs.

Always have a Receive MOB enabled ready to accept any incoming messages. Thanks to the implementation of the CAN interface, a Receive MOB must be enable at latest, before the 1st bit of the DLC field. The Receive MOB status register is written (RXOK if message OK) immediately after the 6th bit of the End of Frame field. This will leave in CAN2.0A mode a minimum 19-bit time delay to respond to the end of message interrupt (RXOK) and re-enable the Receive MOB before the start of the DLC field of the next incoming message. This minimum delay will be 39-bit time in CAN2.0B. See CAN2.0A CAN2.0B frame timings below.

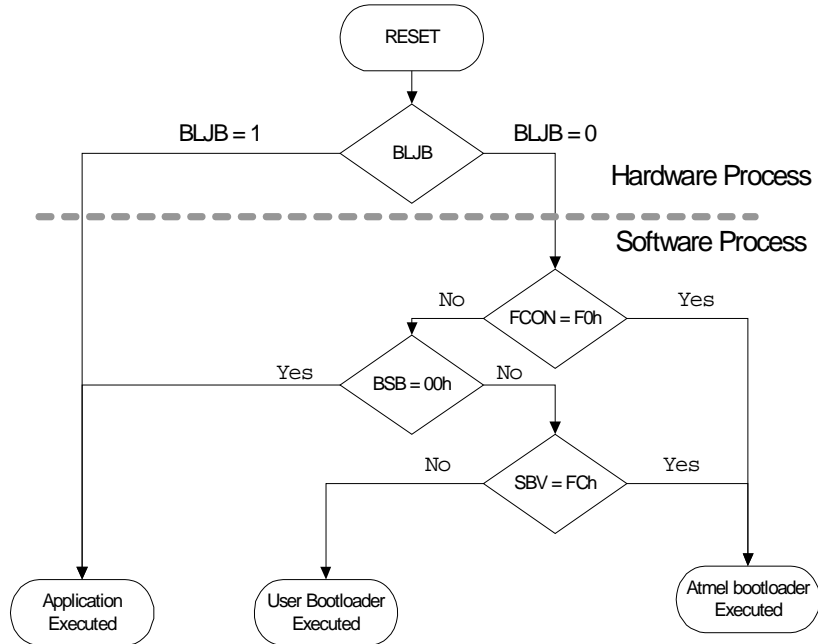
Version 1.2:

4. Boot Process Compatibility

There are some differences between Boot process of bootloader 1.2 and newer versions (see below).

Use the fuse bit BLJB to start the application in both versions.
