Active Errata List

CAN Microcontrollers

T89C51CC02

Errata Sheet

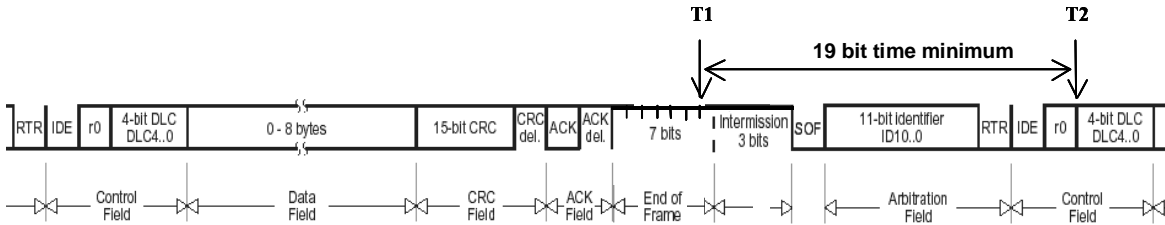
13. Transmission after a 3 bit Intermessage

If a Transmit Message Object (MOB) is enabled while the CAN bus is busy with an on going message, the transmitter will wait for the 3-bit Intermission before starting its transmission. This is in full agreement with the CAN recommendation.

If the transmitter lost arbitration against another node, two conditions can occur :

1. At least one Receive MOB of the chip are programmed to accept the incoming message. In this case, the transmitter will wait for the next 3-bit Intermission to retry its transmission.
2. No Receive MOB of the chip are programmed to accept the incoming message. In this case the transmitter will wait for a 4-bit Intermission to retry its transmission. In this case, any other CAN nodes ready to transmit after a 3-bit Intermission will start transmit before the chip transmitter, even if their messages have lower priority IDs.

Always have a Receive MOB enabled ready to accept any incoming messages. Thanks to the implementation of the CAN interface, a Receive MOB must be enable at latest, before the 1st bit of the DLC field. The Receive MOB status register is written (RXOK if message OK) immediately after the 6th-bit of the End Of Frame Field. This will leave in CAN2.0A mode a minimum 19-bit time delay to respond to the end of message interrupt (RXOK) and re-enable the Receive MOB before the start of the DLC field of the next incoming message. This minimum delay will be 39-bit time in CAN2.0B. See CAN2.0A CAN2.0B frame timings below.
